## ÖSTERREICHISCHER AERO-CLUB

Sicherheitsmitteilung  
SM 202102

## VECTOR 3SE RESERVE PIN COVER FIELD MODIFICATION

## **VECTOR SE (STUDENT) RESERVE ISSUE**

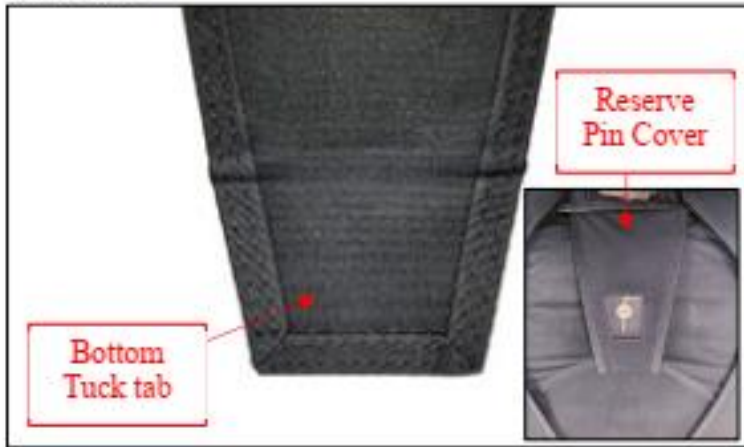
Identify the Reserve Pin Cover flap bottom "Tuck Tab".
